BROOMALLS DAM

DELAWARE COUNTY, PENNSYLVANIA

(NDS I.D. NO. 7 PA 00349,  
DER I.D. NO. 23-9)

PHASE I INSPECTION REPORT  
NATIONAL DAM INSPECTION PROGRAM

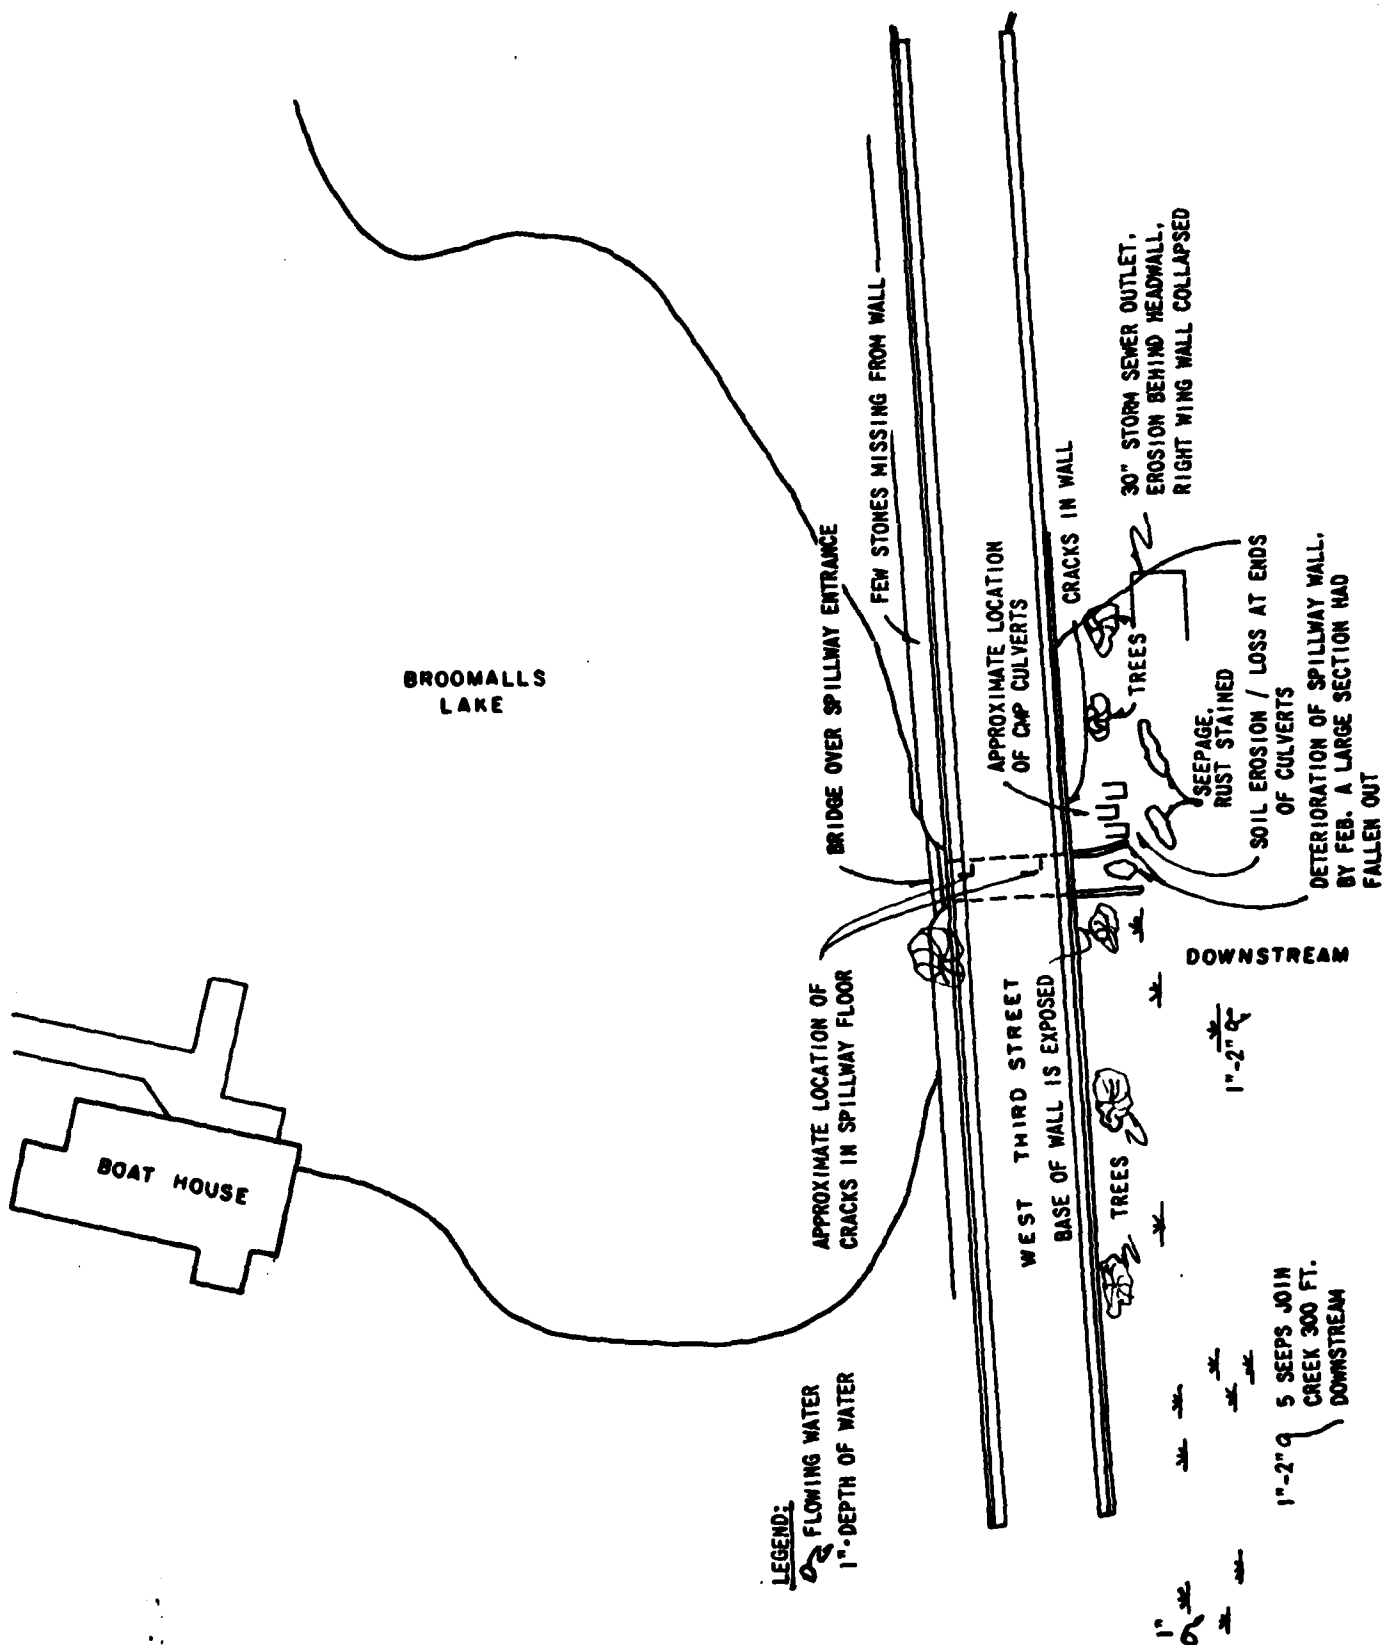
SHEET 5A OF 11

the downstream toe of the embankment to the right of the spillway are marshy areas which can be attributed to seepage under or through the dam embankment. No specific seepage was noted through the embankment to the left of the spillway; however, a good deal of rock is in the area and could mask any seepage. In February, the water level in the reservoir and downstream channel was lower and two seepage areas to the left of the channel were noted as shown on sheet 5a, Appendix A. Both seepage areas are rust stained.
